Interim Assessment of the VAL Automated Guideway Transit System

November 1981
Interim Report

1. Report No. UMTA-MA-06-0069-81-3	2. Government Accession No. PB 82-163783	3. Recipient's Catalog No.	
4. Title and Subtitle Interim Assessment of the VAL Automated Guideway Transit System.		5. Report Date November 1981

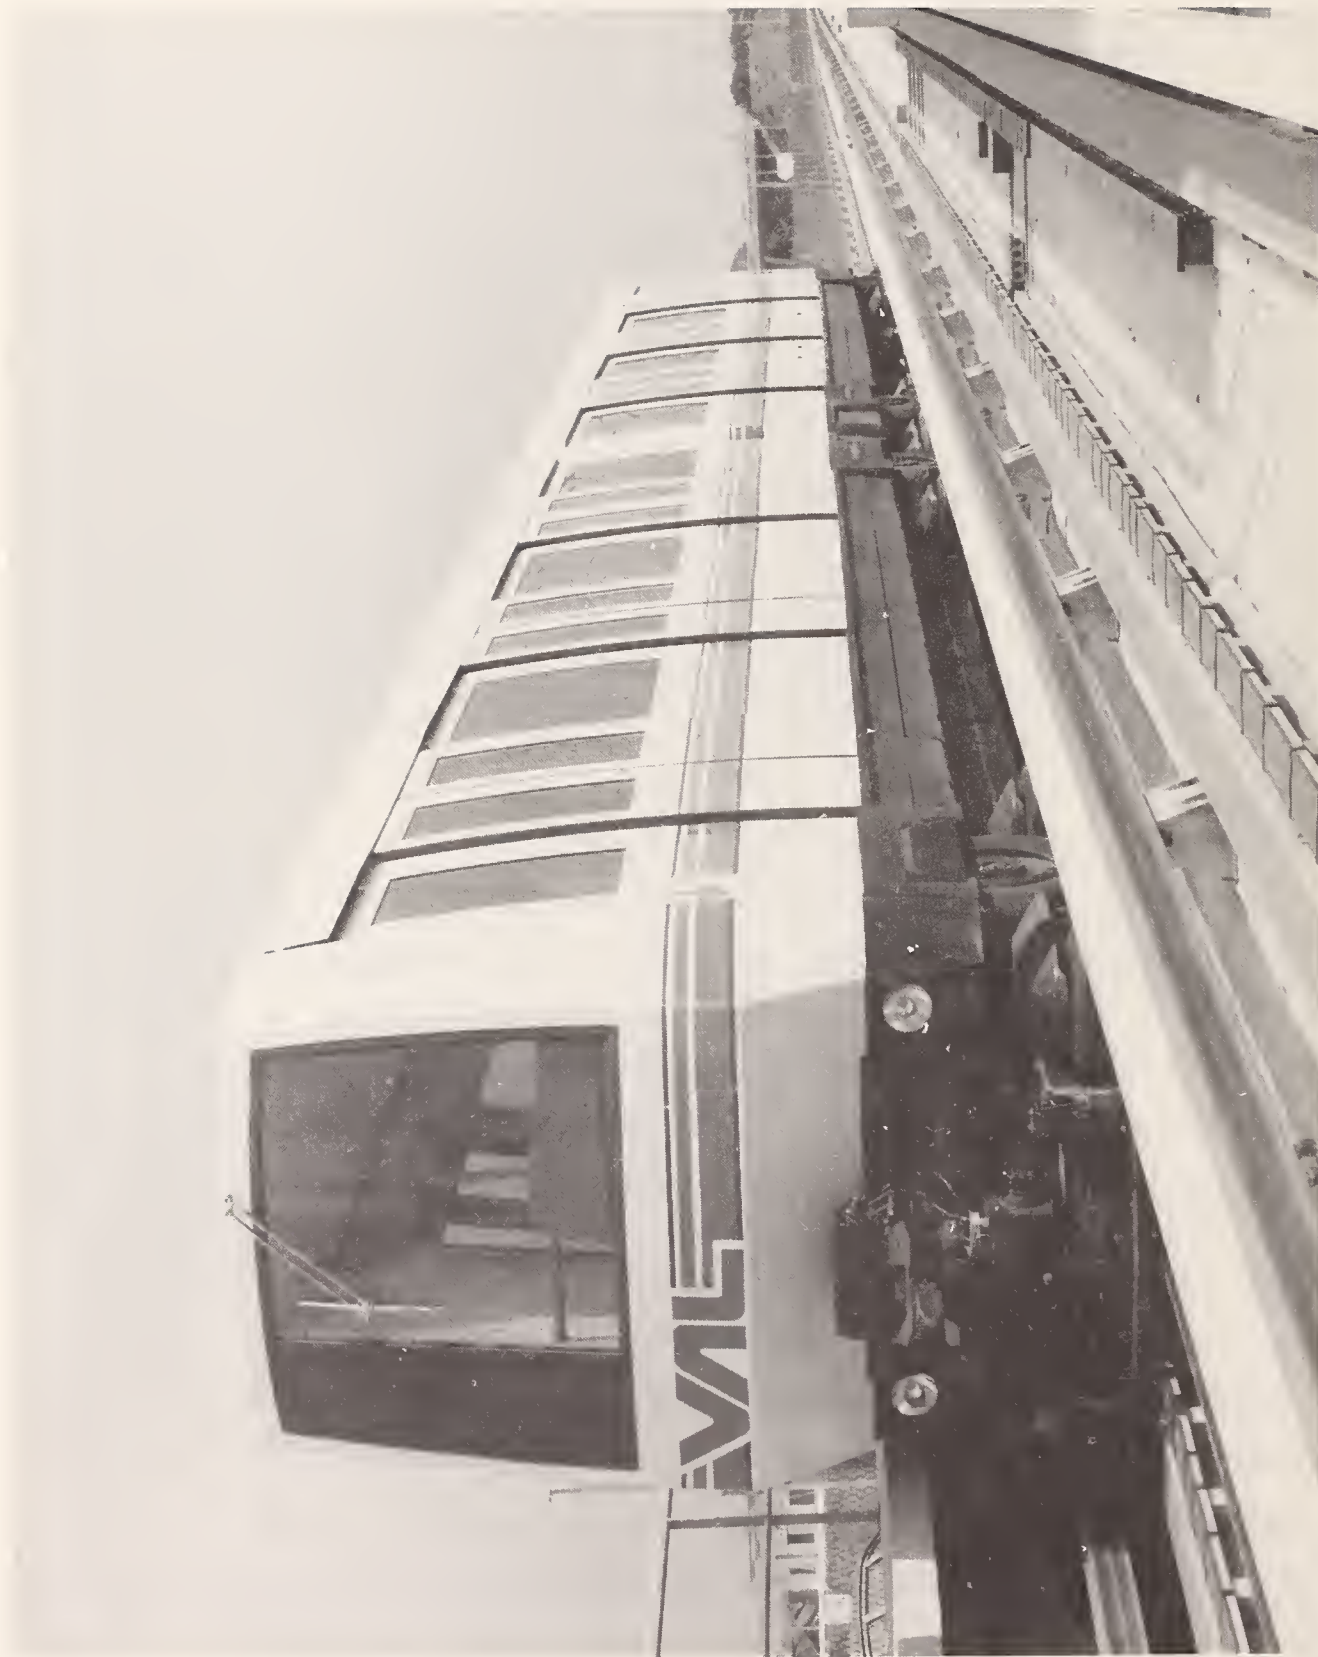
FIGURE ES-1. VAL SYSTEM

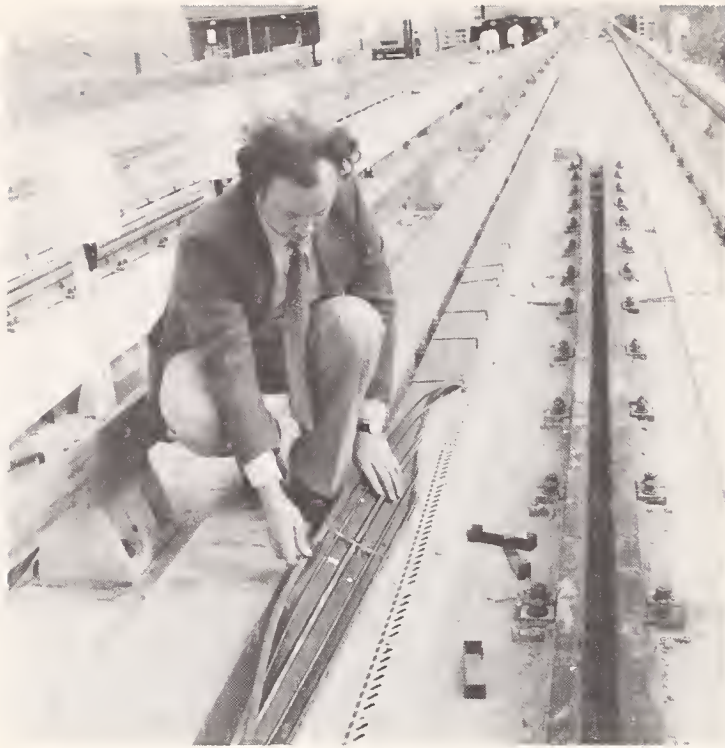
FIGURE 3-26. INDUCTIVE LOOP TRANSMISSION LINES

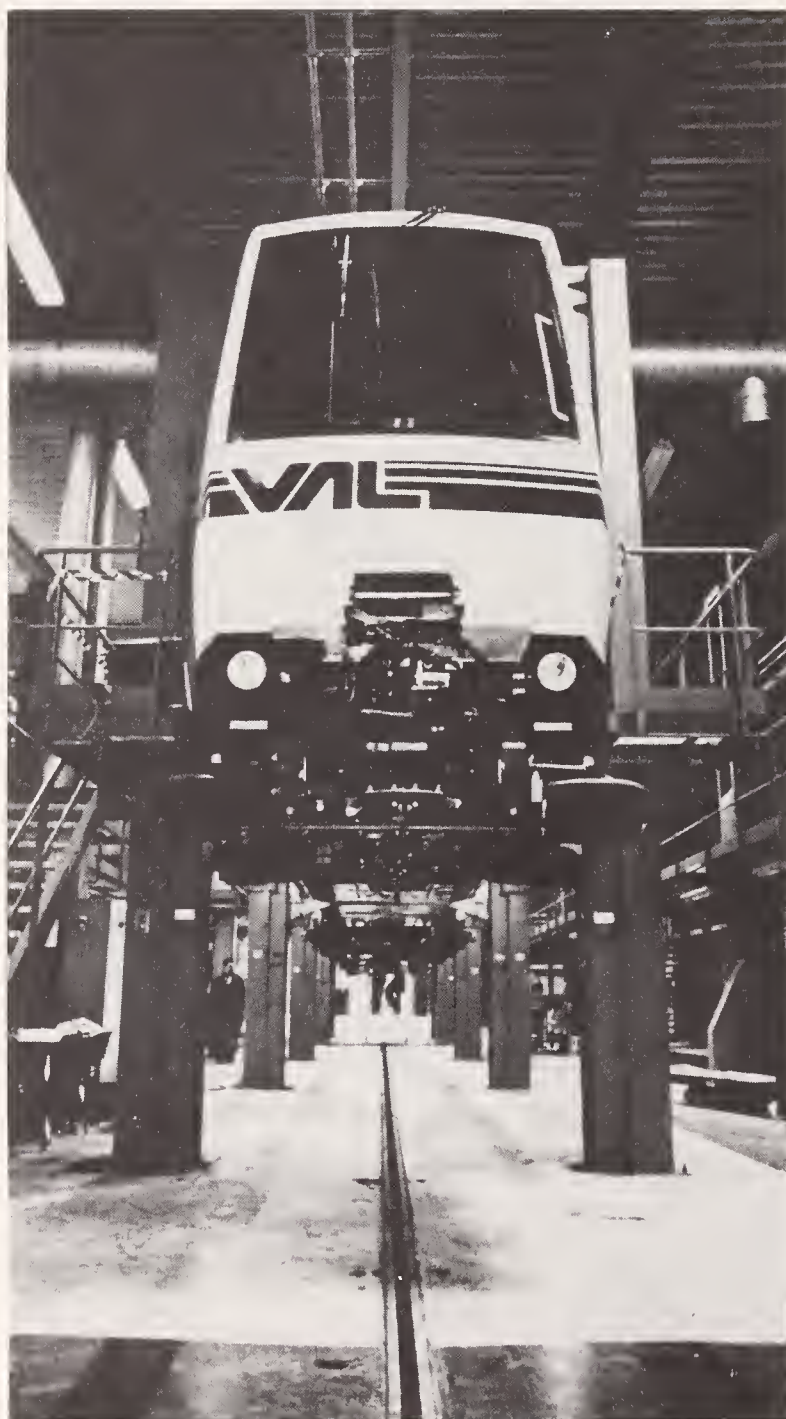
FIGURE 3-43. VEHICLE ON LIFT

a workshop with six bays (see Figure 3-42). Each bay has eight synchronized lifts that lift the entire vehicle unit (see Figure 3-43). This allows easy access for maintenance personnel and equipment without restrictions.
